Solubility of limestone and seepage problems in the left abutment of the Marun dam, southwest of Iran

M.H.Ghobadi: Bu-Ali Sina University,
Geology Department,
R. Karami: Shahid Chamran University,
Geology Department, Ahvaz

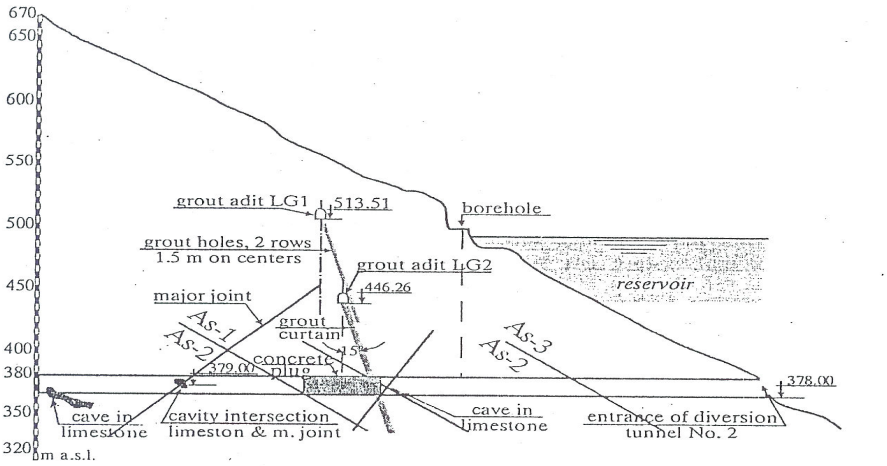
Fig. 4. A profile of the second diversion tunnel in the left abutment.

During the first reservoir impounding, the old karst channels along "Vuggy Zone" cut by the second diversion tunnel were reactivated and leakage occurred. Discharge started in gallery LA-3 about 40 l/min (Fig.3 and 4).

The reservoir level was 40m only. As a consequence of washing process discharge from LA-3 in few days increased to $1.5 m^3/s$. Simultaneously, much larger leakage appeared at several places in the second diversion tunnel, and at a few more points in galleries and

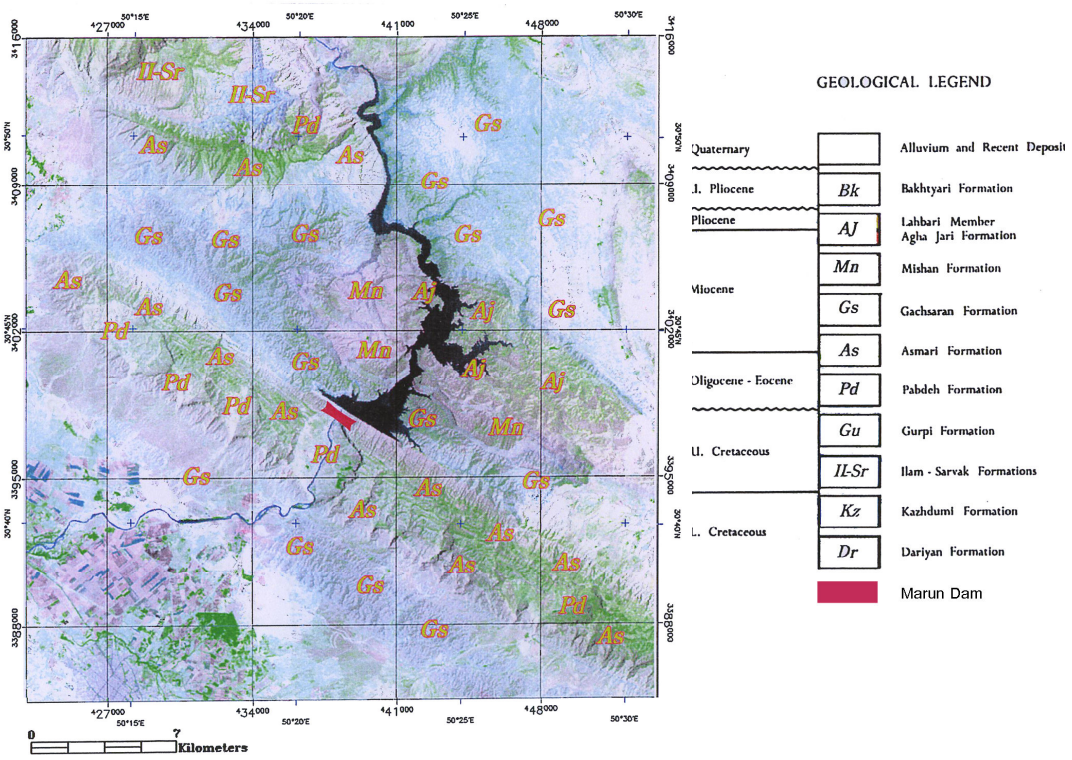
Fig.6. Geological map of the investigation area.

The dam site is situated in the Zagros Mountain in southwest Iran. This region presents continuous series of sedimentary ranging in age from Cretaceous to Pliocene. This sequence mainly consists of limestone, marl, shale and gypsum (Fig.6). The oldest units at the site are Eocene limestone, marl and shale, which are exposed upstream of the dam site. Overlying these rocks is the Asmari formation, a series of limestone unit's with marl, dolomite and shale. The Asmari formation is major ridge-forming rock in the site area and forms the entire foundation of the dam. The dam is situated on the north flank of anticline on the low karstified middle Asmari limestone (As-2). The lower Asmari limestone (As-1) consists of a relatively permeable

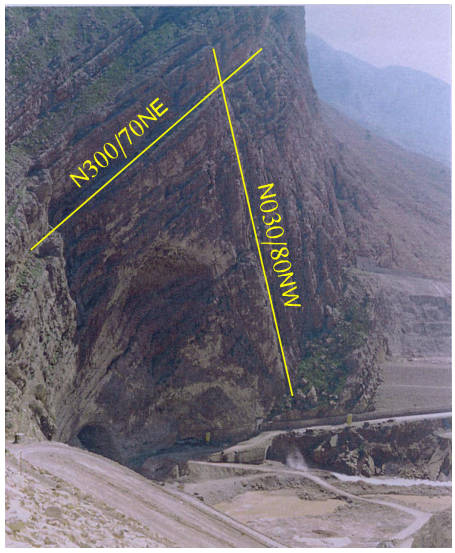
Fig.8. Several joint sets cut the Asmari limestone at the site. The rock mass is cut by two major sets of joints. One major joint set strikes 030 and dips 80 degree NW. The other major joints set strike 300 degree and dips 70 degree NE.

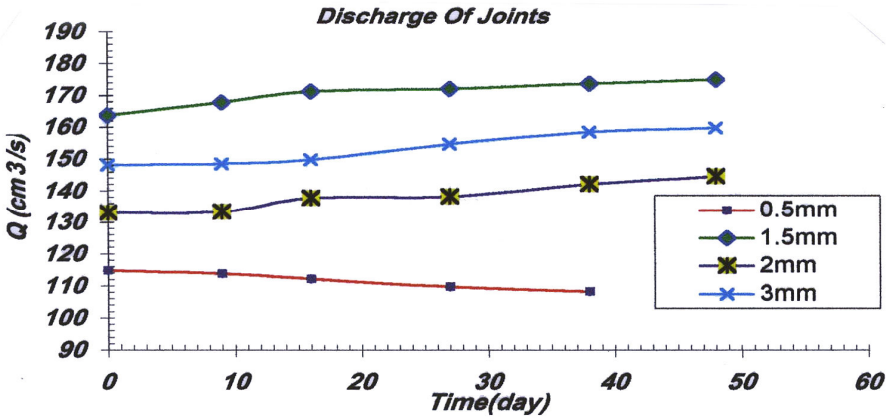
Analysis of data showed that the increase of aperture of joints would cause an increase in the diffusion phenomenon. This process will cause more sedimentation at the smaller aperture 0.5 mm. Artificial joint of 0.4 mm aperture closed after 20 days and the amount

of discharge in artificial joint of 0.5 aperture reduced %42 during 72 days (Ghobadi 1997,2005). In this research the reduction of water discharge through aperture of 0.5 mm and the increase of water discharge through aperture 1, 1.5,2 and 3 mm during 52 days (Fig.9).

Fig.9. The reduction of water discharge through aperture of 0.5 mm and the increase of water discharge through aperture 1.5, 2 and 3 mm during the testing period.

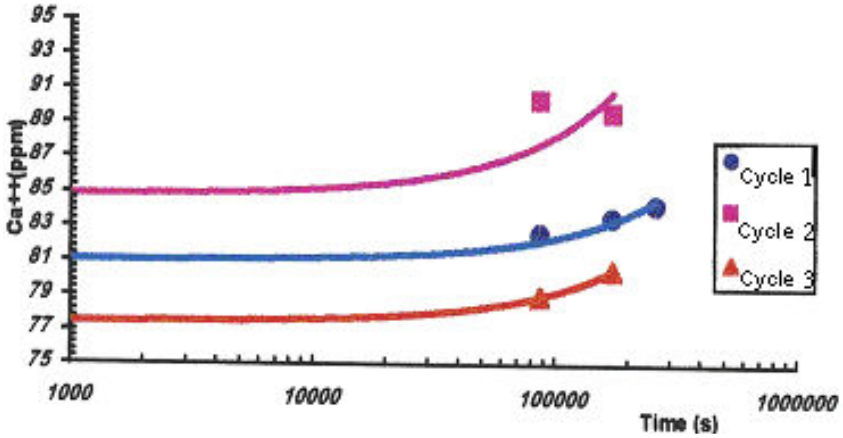
The rate of solution of samples was measured using solution of carbon dioxide of different concentration in the phases. Typical plots are given in Figure10. From these plots the computer program was able to extract a value of K_c. Average of solubility rate constant (K_c) in cm/s was determined by the following equation:

Where V is volume of water, A is the area of rock surface exposed to aqueous solution at any time t, d_c and d_t are change in concentration and time respectively, C_s is saturated concentration, C is concentration and $n = 2$. The average of solution of limestone samples were $K_c = 3.15\times10^{-7}\, cm/s$ for 8 samples (Table 1). It can be concluded that the solubility of Asmari limestone is low (Ghobadi 2004, 2005b).

Fig.10. Dissolution of calcium carbonate versus log of time for three phases in carbon dioxide of different concentration. Phase 2 selected for determined of K_c .
